240115 Main St

Anderson Foundation Inspections

DISCLAIMER

WATER, NO REPAIRS REQUIRED, WATER STAINS, FOLLOW MAINTENANCE RECOMMENDATIONS BELOW

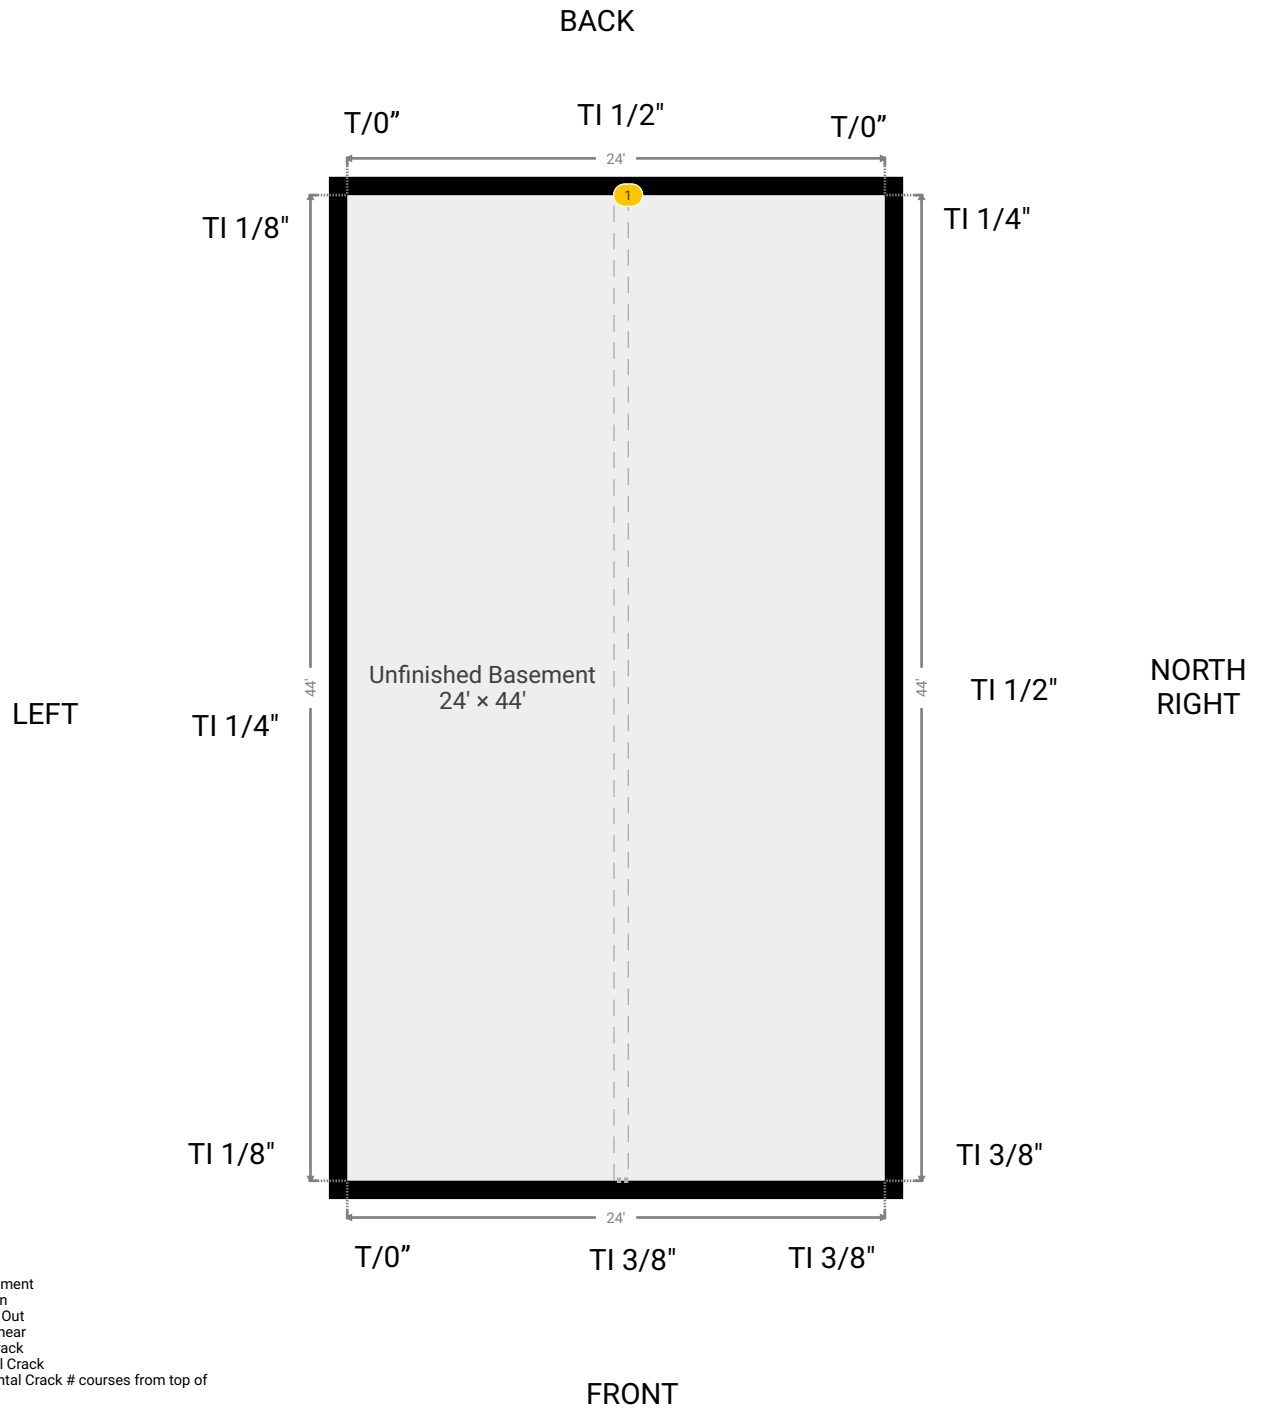
▼ Basement

TOTAL AREA: 1055.73 sq ft • LIVING AREA: 1169.96 sq ft •

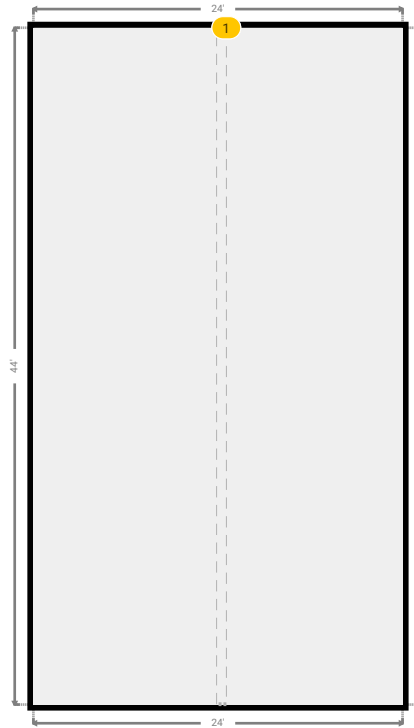
▼ Unfinished Basement Basement

WIDTH: 24' • LENGTH: 44'
AREA: 1056.00 sq ft • PERIMETER: 136'
